Interest of new observation techniques to understand and improve steel microstructures and fracture properties

P. Barges, S. Cobo, L. Germain, J. C. Hell, M. Kahziz, M. Maziere, T. Morgeneyer, A. Perlade, J.M. Pipard, C. C. Tasan, M. Salib, M. Wang

Aussois 2019 – 21-25 jan. 2019

Rupture des Matériaux et des structures – Mécanismes et modélisations face aux applications industrielles

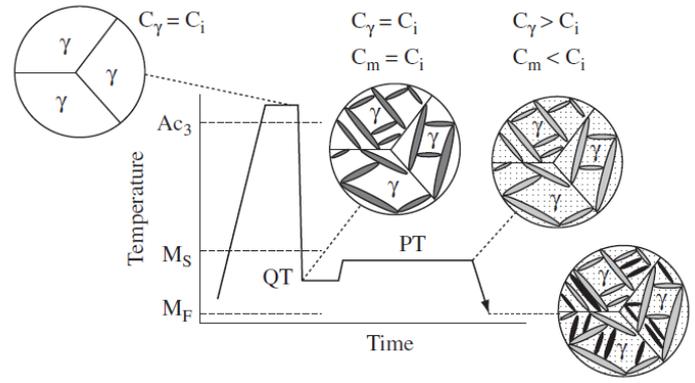
Schematic illustration of the Q&P process. Courtesy of J.G. Speer.

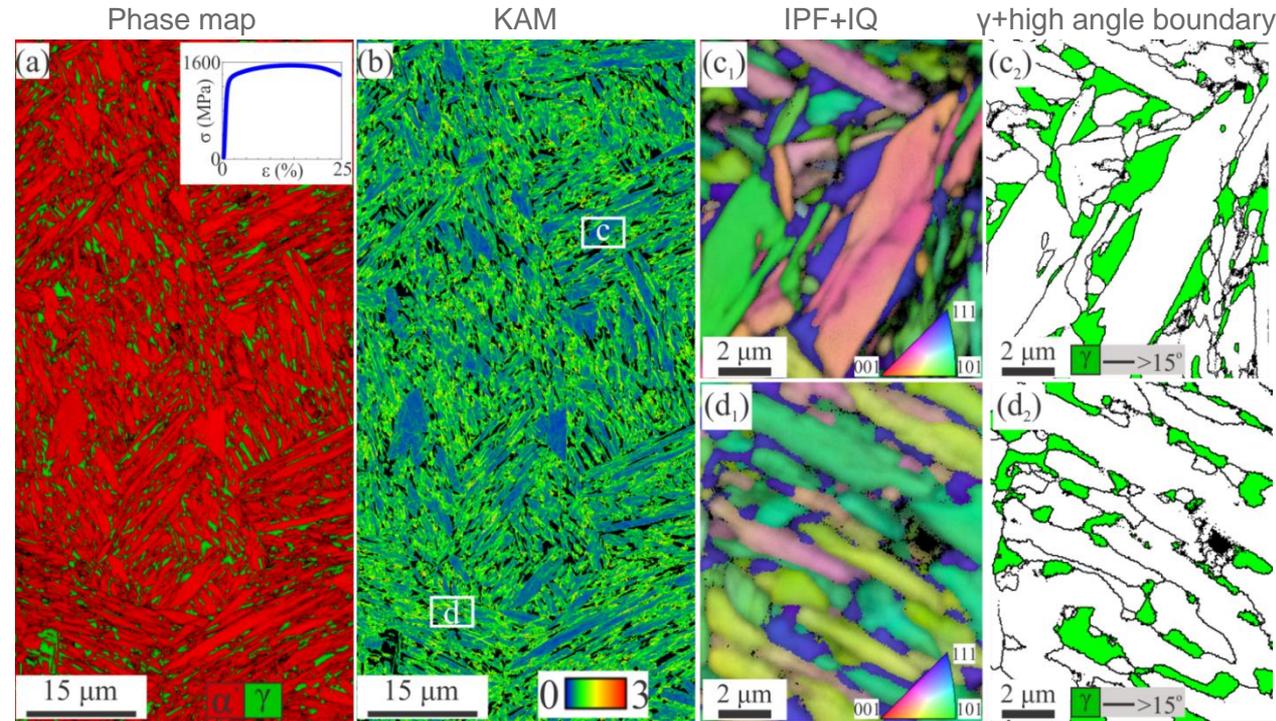
Typical Q&P microstructures

• Constituents

- Tempered martensite (TM)
- Retained austenite (RA)
- Un-tempered martensite (UM)
- Bainite

• Size distribution

- Coarse TM laths
 → $2.95 \pm 1.01 \mu\text{m}$
- Fine TM laths
 → $0.92 \pm 0.35 \mu\text{m}$

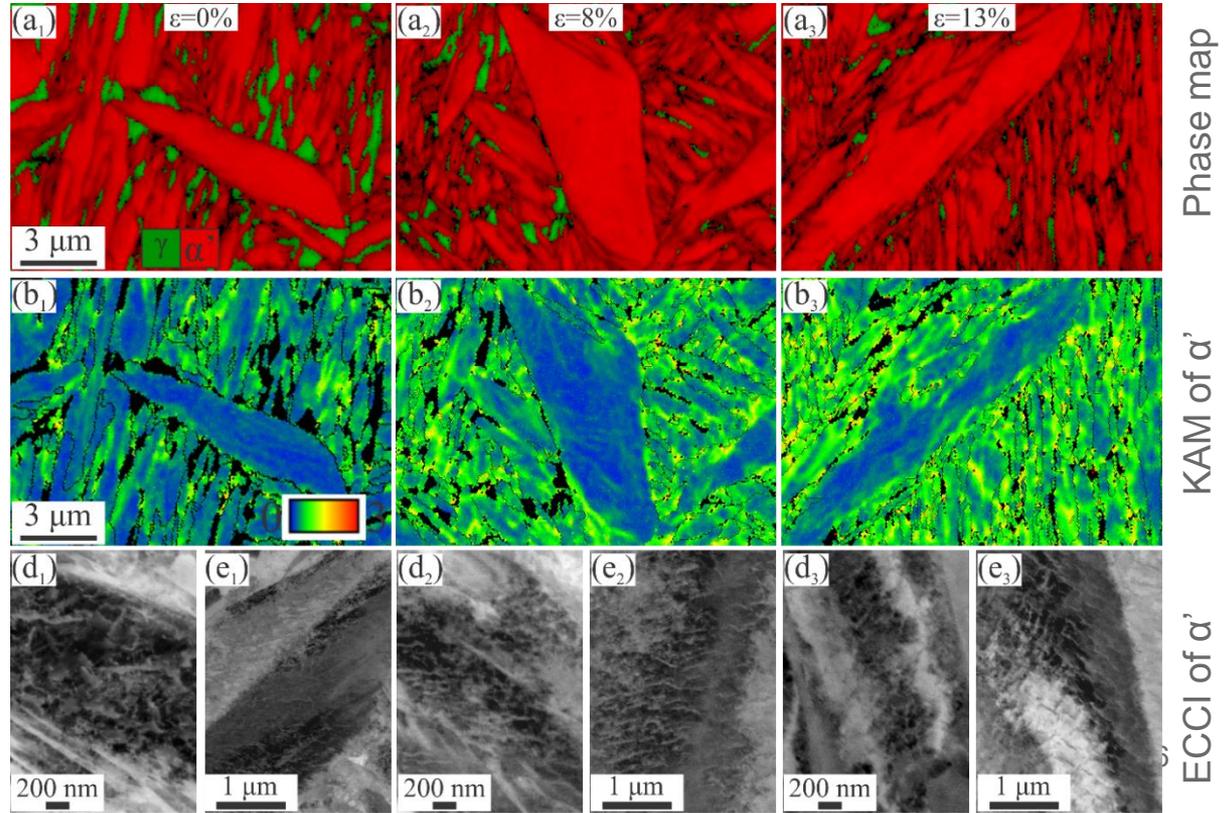
Deformation mechanisms

- Continuous transformation of γ into α' leading to TRIP
- Dislocation-mediated plasticity in α'

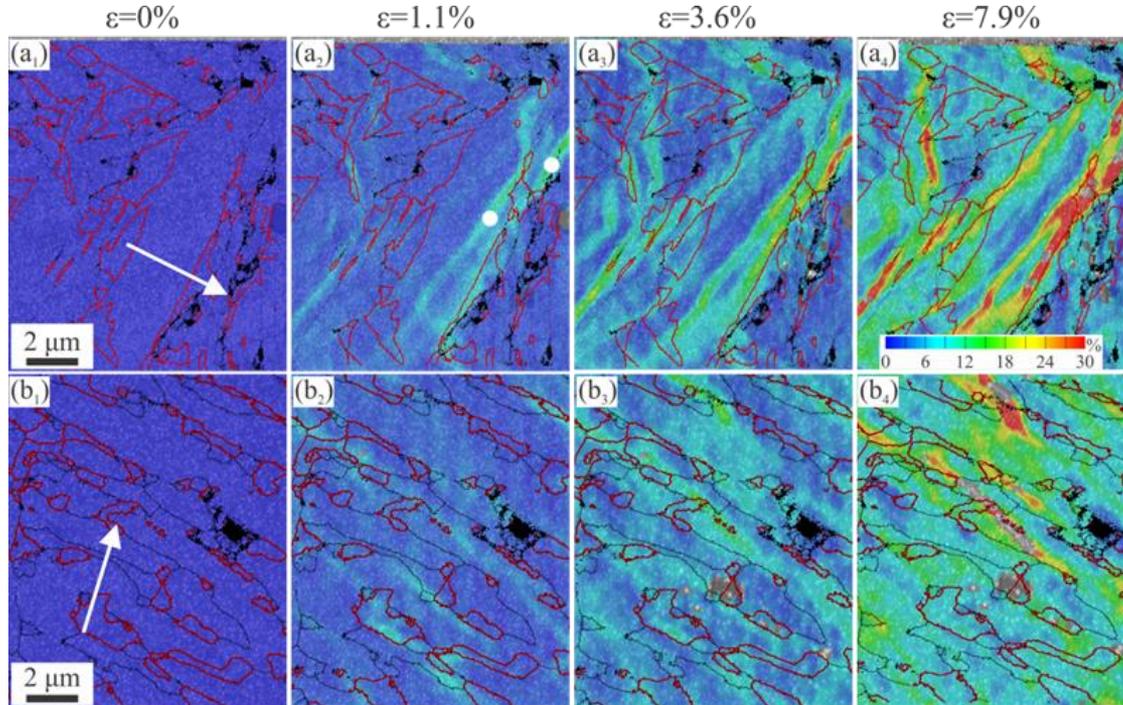
Deformation mechanisms - Strain mapping

In situ tension with High-resolution DIC based on in-lens image of silica particles

- Areas with coarse TM laths
- Heterogeneous strain distribution
- Early strain localization along coarse TM lath interfaces
 - Strongly dependent on neighboring constituents
 - Presence of UM at interfaces increase strain localization

- Areas with retained austenite and fine martensite laths
- Homogeneous strain distribution
- Plastic strain occurs first in RA

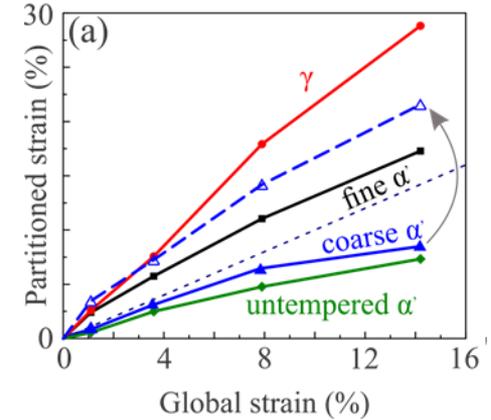
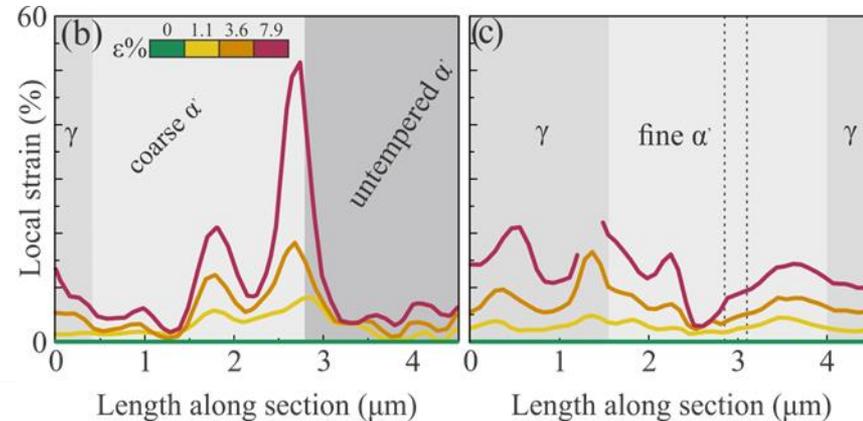
Strain partitioning of each phase

- Strain partitioning
 - Retained austenite exhibits highest level of plasticity
 - Followed by martensite laths (fine then coarse)
 - Coarse TM laths partition lower strain than fine TM laths but it depends on its neighbors
 - Untempered martensite shows the lowest level of plasticity
- Simultaneous presence of coarse lath and untempered martensite seen as most detrimental zones for damage nucleation in Q&P steels

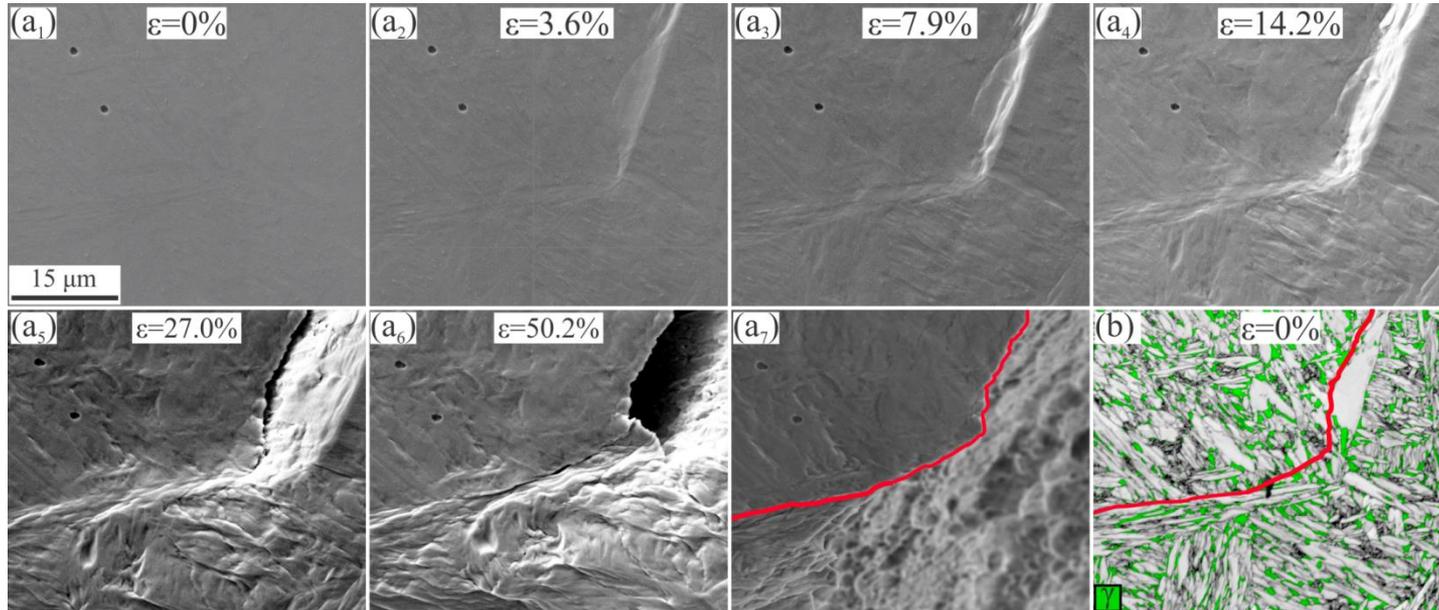
Fracture behavior

Detrimental effect of high strain heterogeneity built-up in coarse martensite laths in vicinity of untempered martensitic zones

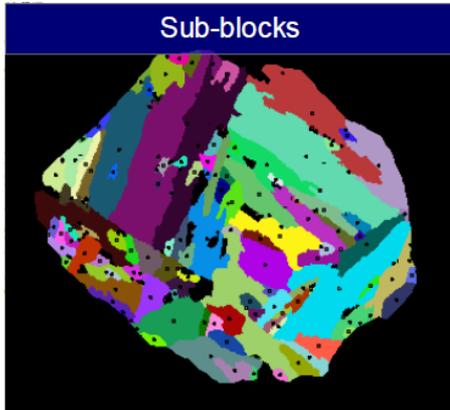
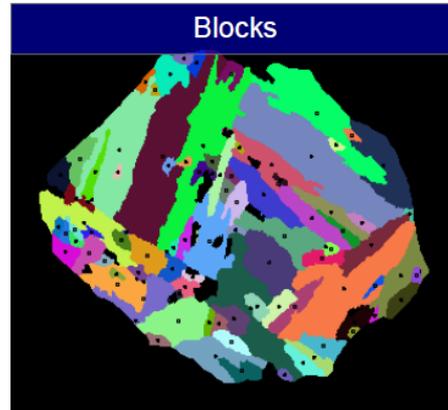
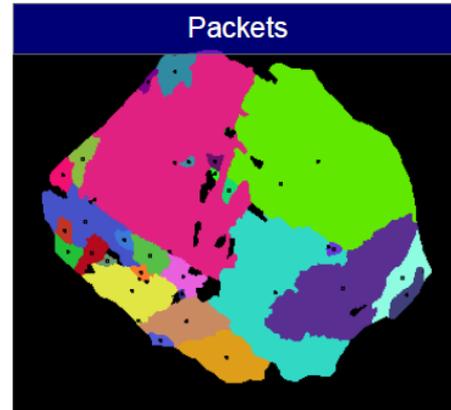
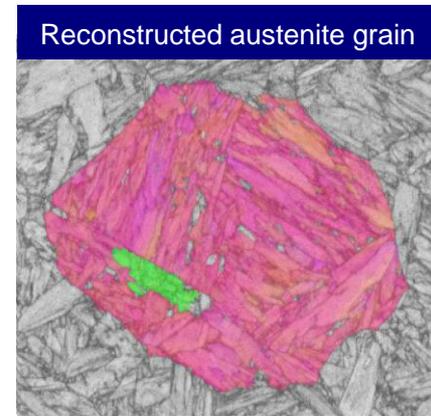
- Step 1: Clearly identify the martensite micro-constituents using EBSD
 - Grain reconstruction using **Merengue2** software
 - Automatic quantification of martensite sub-structure using **Decrypt** software

Sub-blocks

Blocks

Packets

Reconstructed austenite grain

2 sub-blocks per block
1 variant of laths in each sub-block

3 blocks per packet

4 crystallographic packets

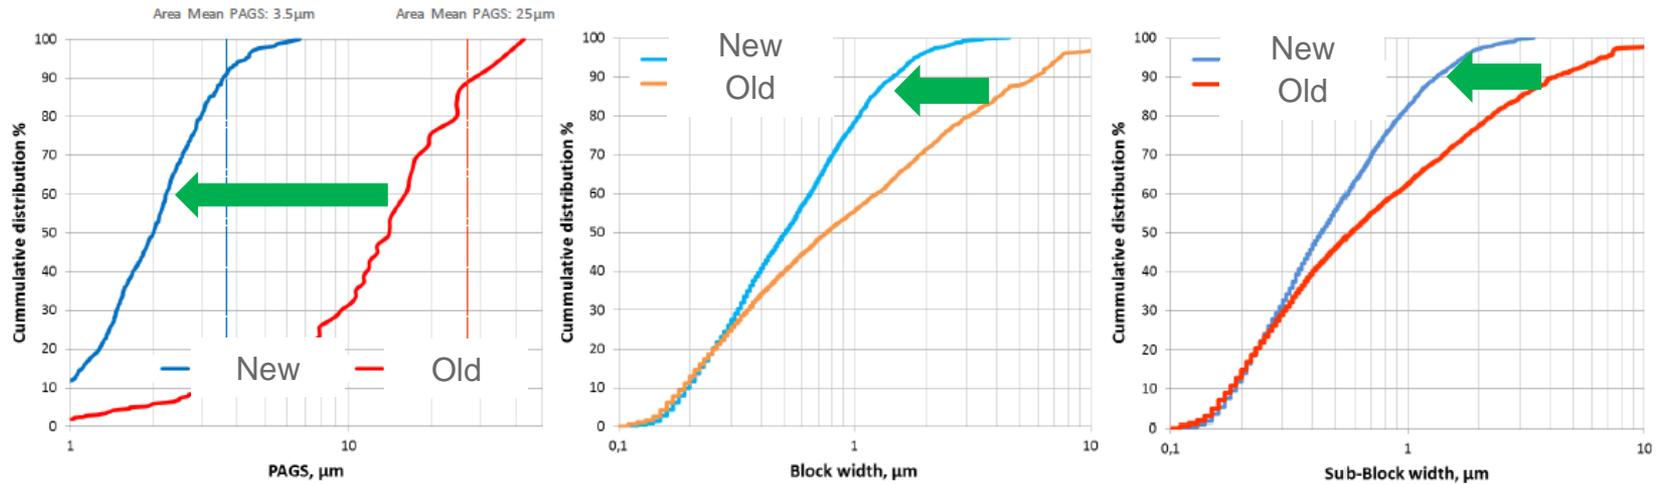
- Step 2: Find the appropriate metallurgical actuator
- In this case, refinement of prior austenite grain size (PAGS) is an efficient actuator

PAGS refinement induces a reduction in microstructural heterogeneity and minimizes the presence of 'coarse laths'

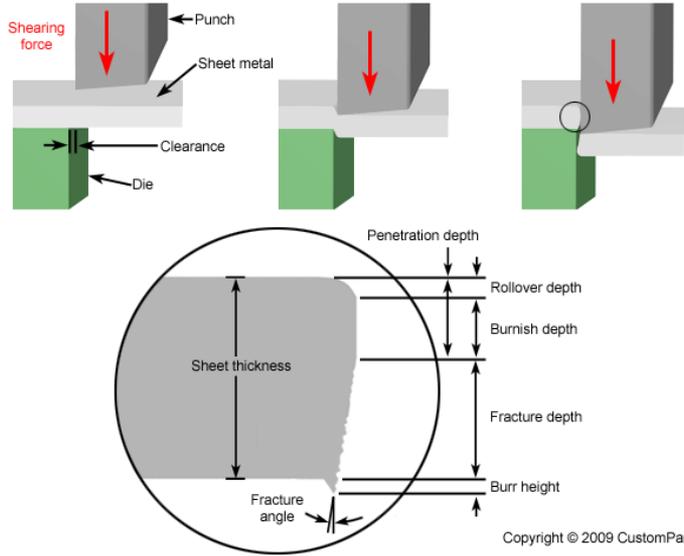
➤ Cutting process and cut-edge profile

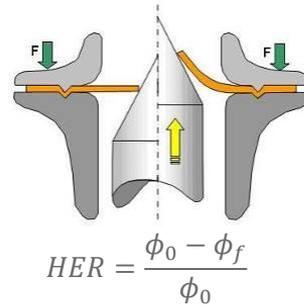
➤ Formation of cracks from the cut-edges during forming process

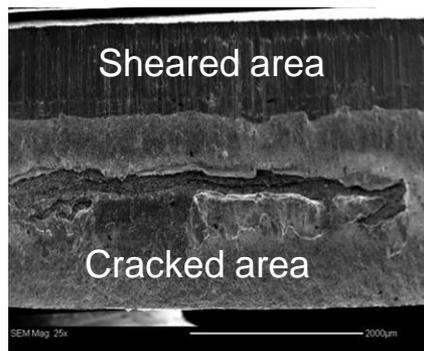
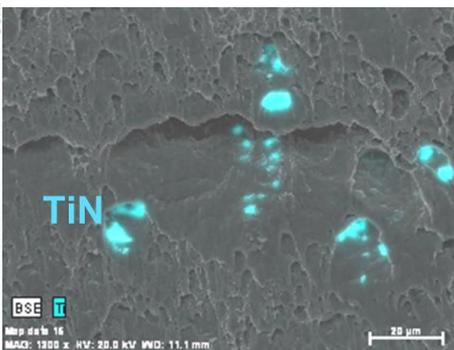
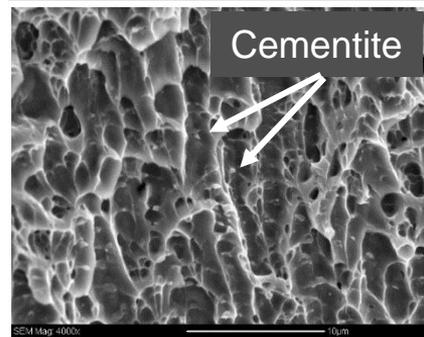
On fracture surfaces

- After punching, before hole expansion

EDS, etching, image analysis (dimple size & distribution)

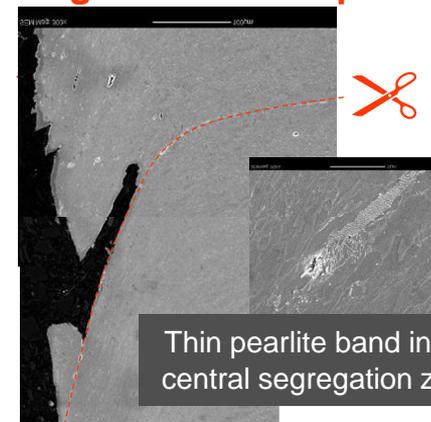
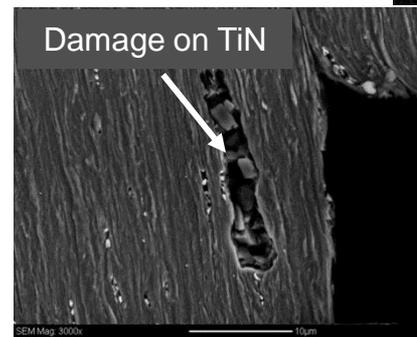
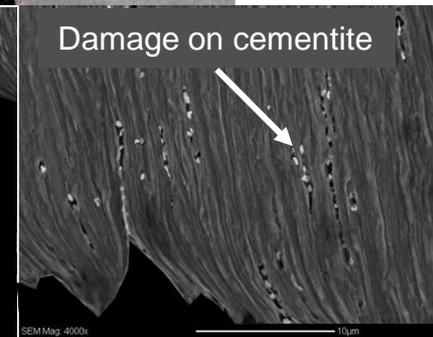
On cross-sections

Voids quantification & link with microstructural features

Damaged zone ~ 150µm

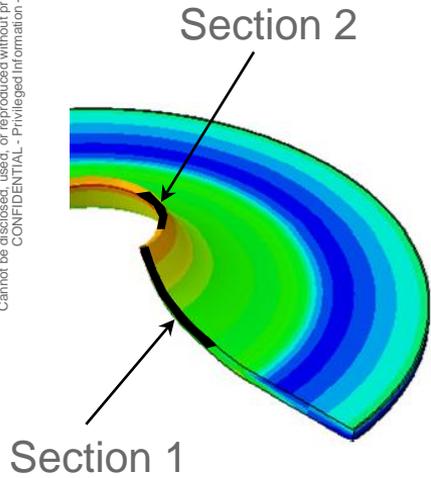
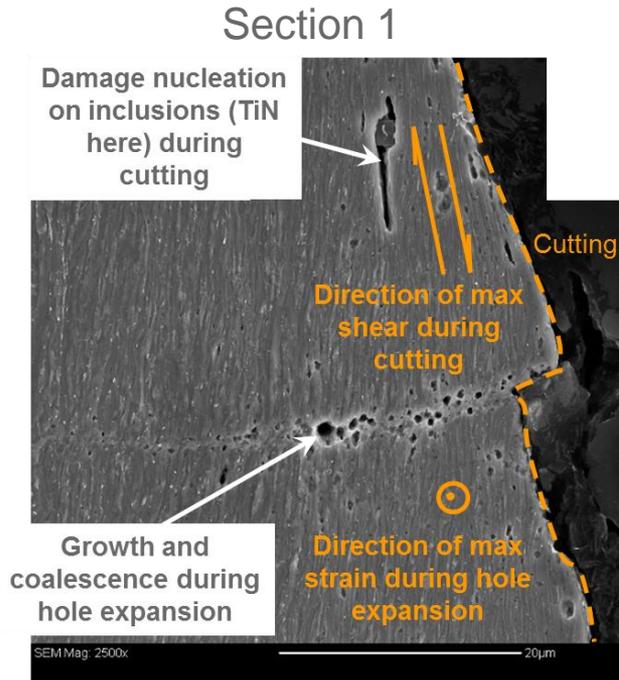
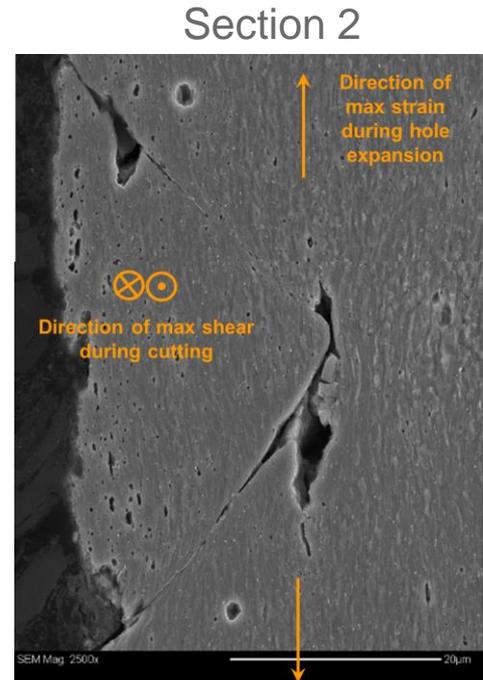
- After punching & hole expansion, on different cross sections

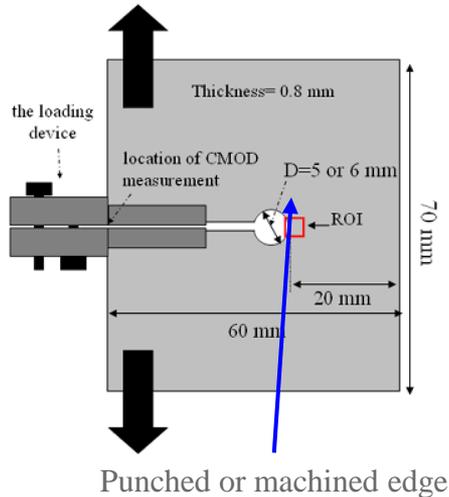
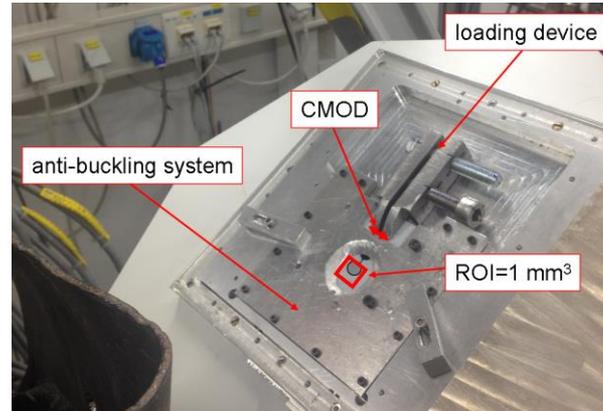
- In-situ X-ray laminography to study the cut-edge
 - An original sample designed to investigate the cut-edges and its damage in-situ.
 - 3D characterization of the damage induced by cut-edges after punching and during straining.

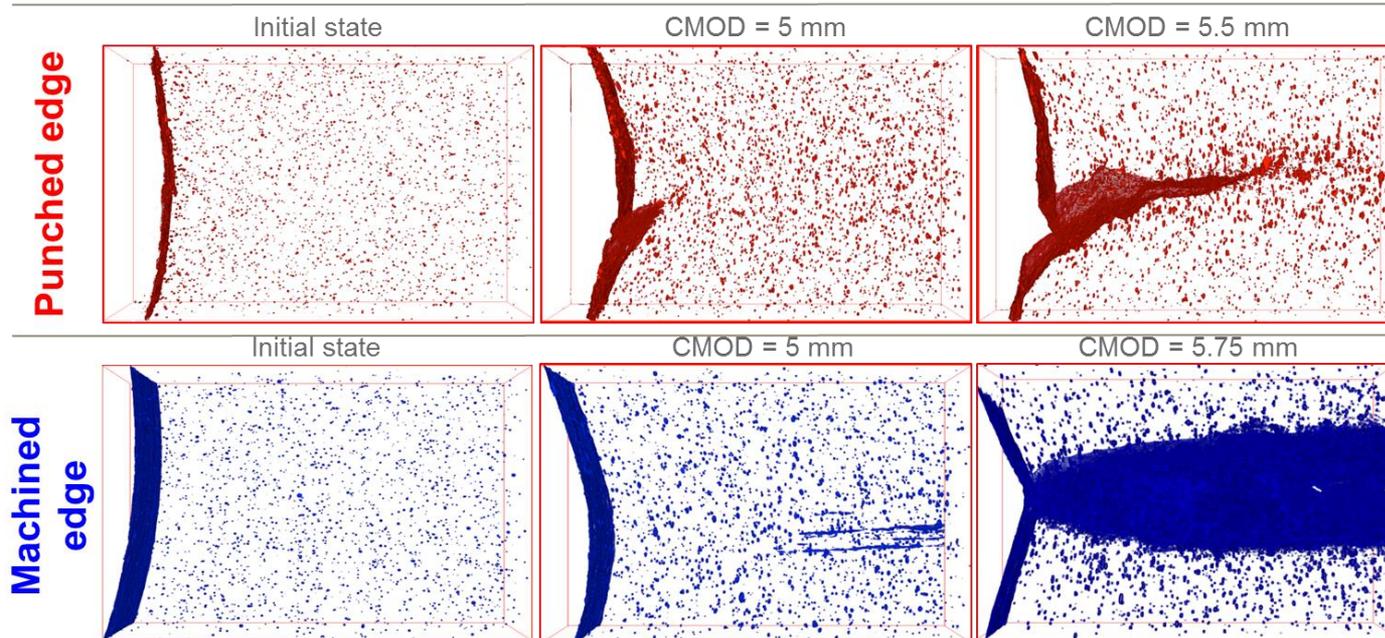
Edge fracture mechanisms

- Initiation of a crack from the cut-edge with slant propagation. Damage quantification
- Initiation from the bulk in the case of the machined edge.

1240×930×310 μm^3

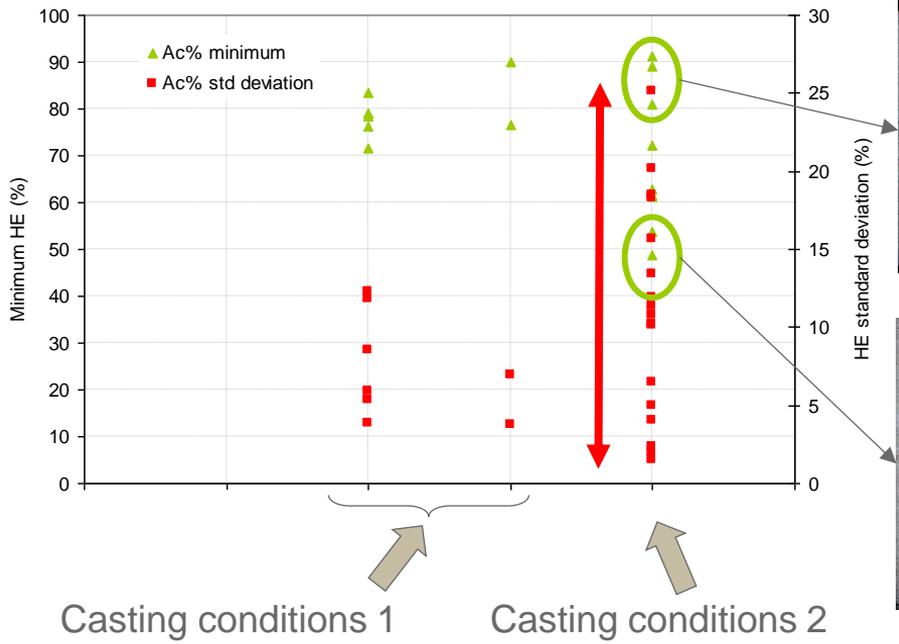
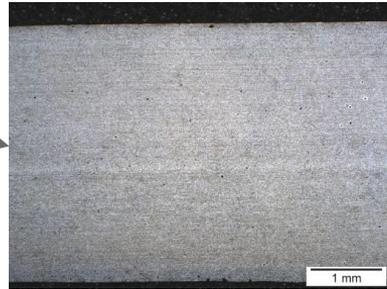
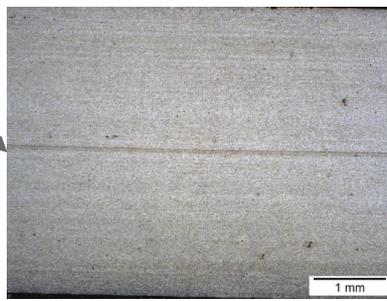
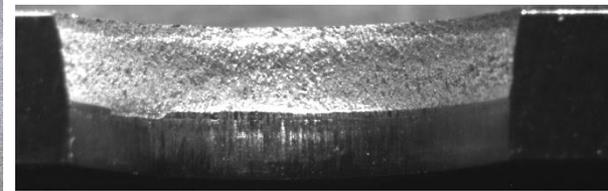
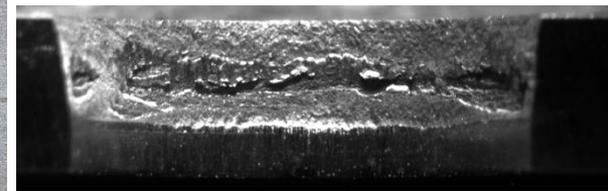
Reduce central segregation during casting is beneficial

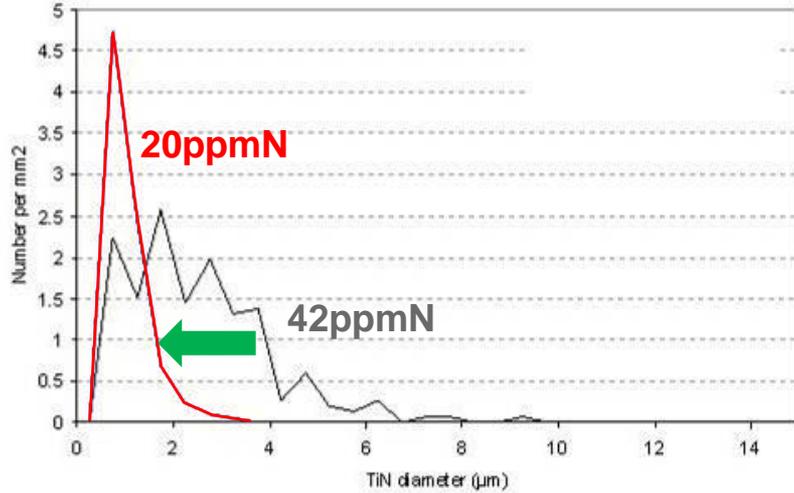
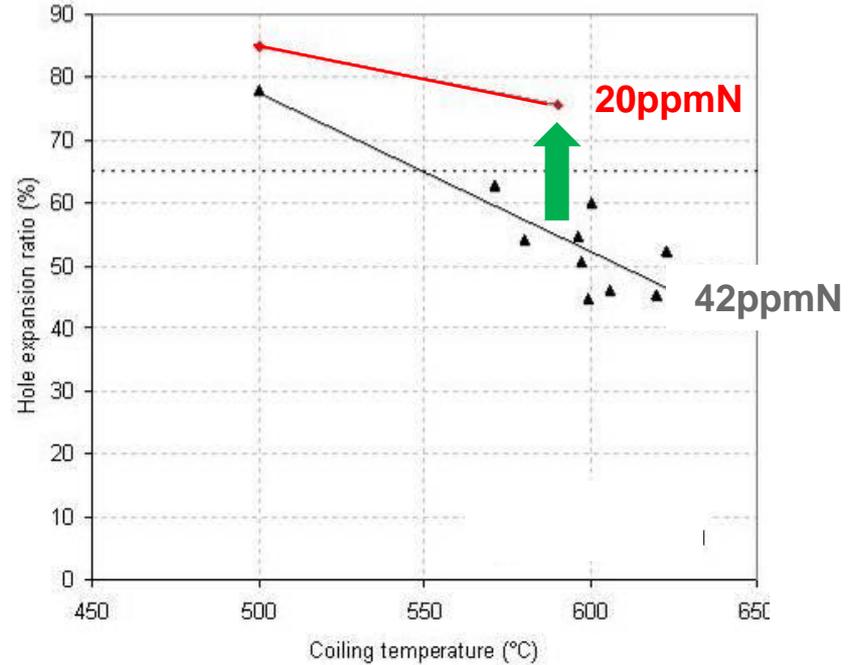
Reduce size of inclusions is beneficial

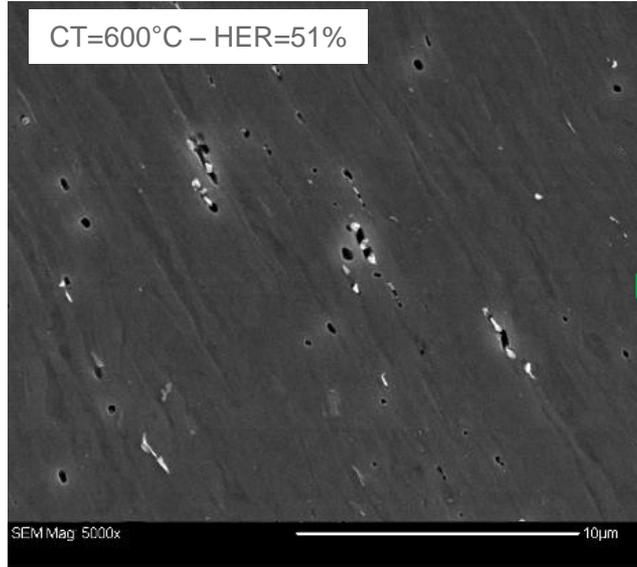
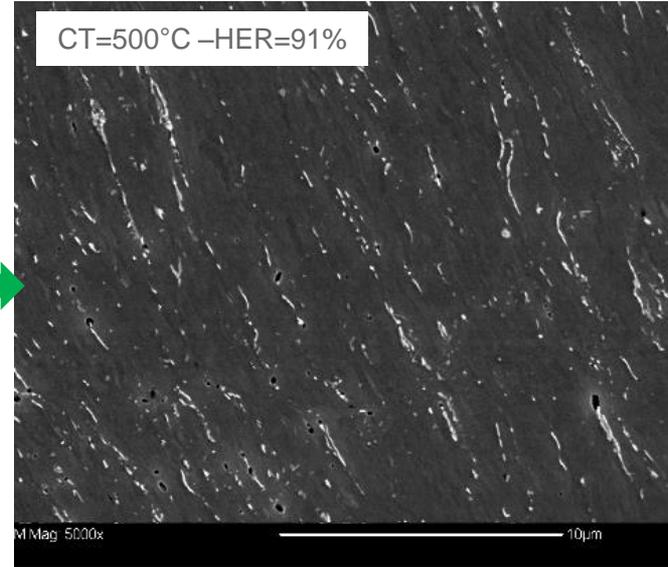
Control size and morphology of cementite is beneficial

- Decrease the coiling temperature leads to a strong change in the cementite morphology and a significant improvement in Hole expansion ratio
- Blocky cementite formed from ferrite is much more detrimental than fine cementite precipitated after bainite stasis

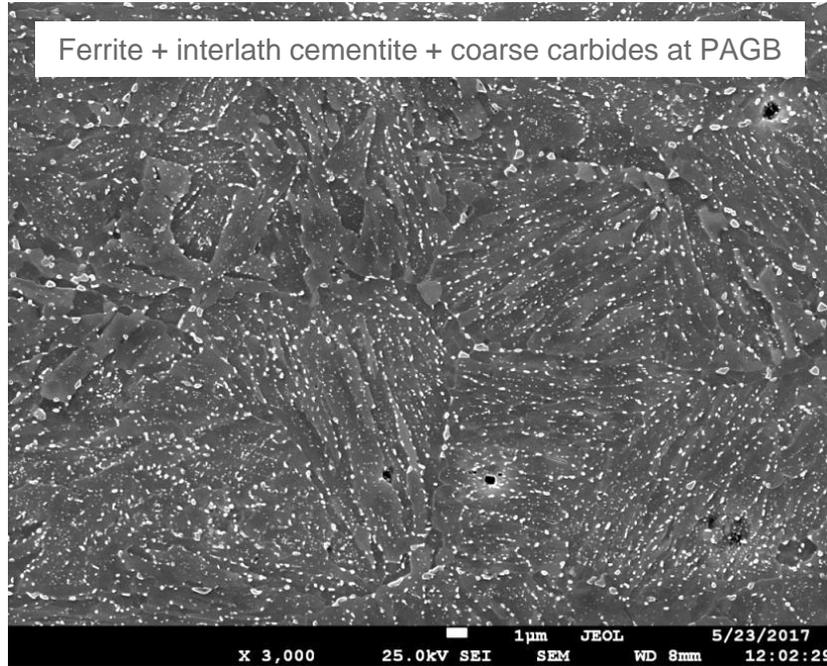
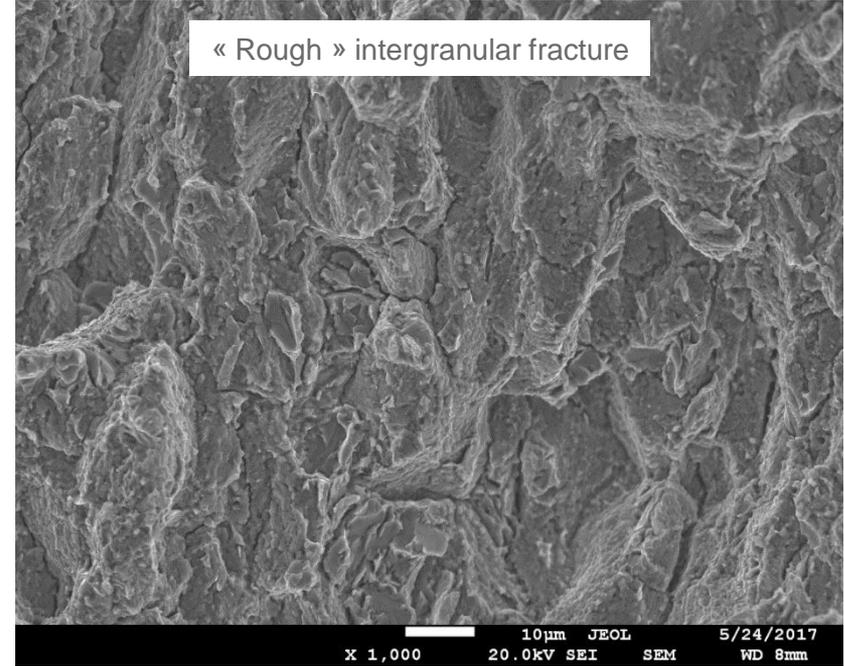
The problem: Low Charpy toughness after tempering of AHSS

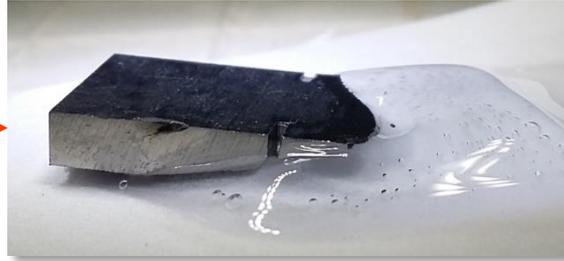
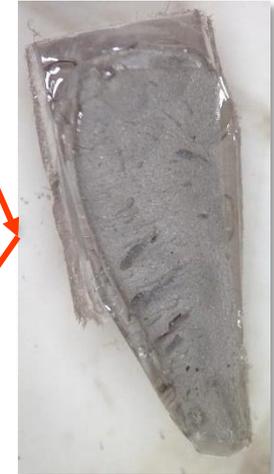
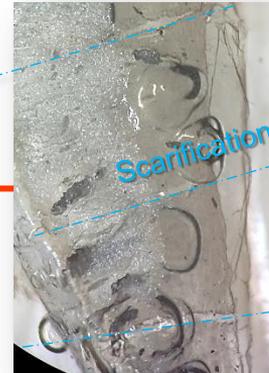
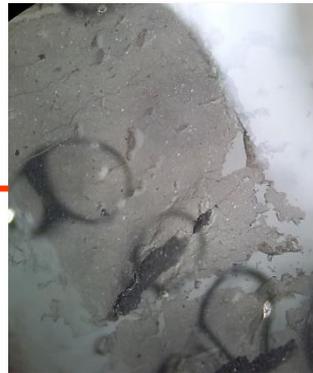
Indirect Rodoïd/Carbon replica on Charpy fracture surface and TEM observations

2% nital etching
of the fracture surface

Application of a polymer (Rodoïd)

Lifting of the Rodoïd

Carbon deposition

Scarifications

Dissolution of Rodoïd with acetone

Carbon replica deposition on Cu grid

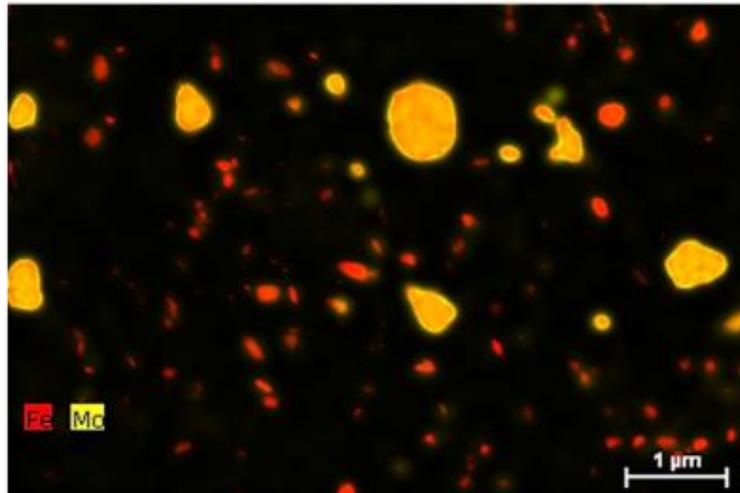
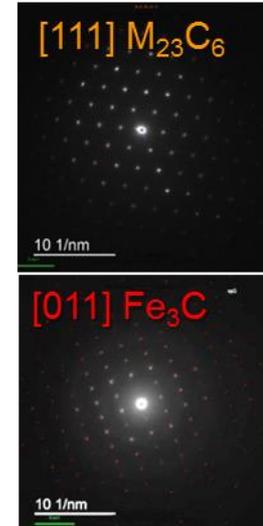
Identification of brittleness root cause

- Numerous $(\text{Fe,Mn,Mo})_{23}(\text{B,C})_6$ extracted on the fracture path of the tempered grade, while Fe_3C only are extracted in the bulk.
